# Manhole Inspection Summary

Manhole # S05UU1002MH

Insp Date: **8/6/06 12:00 AM**

**Location** Address: **3500 W NORTHERN PKWY**

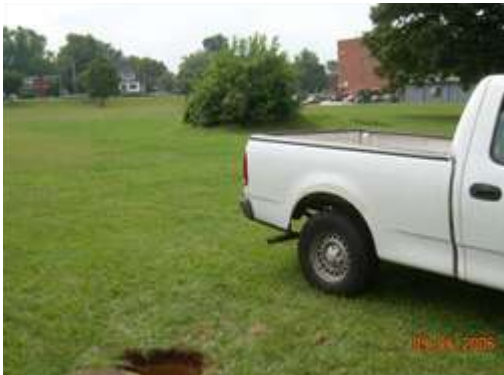
Location View

Comments **The MH is located in the school yard.**

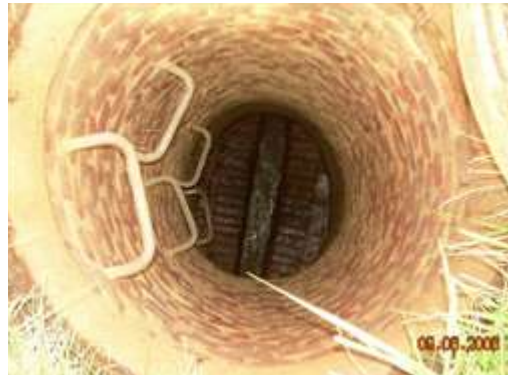
Top View

Condition: ☐ Sound ☐ Cracked ☒ **Root Intrusion** ☐ Loose Brick ☐ Deteriorated

Condition: ☐ Sound ☐ Cracked ☒ **Root Intrusion** ☐ Loose Brick ☒ **Deteriorated**

**Steps** Count: **8** Missing: **0** ☒ **Corroded**

**Surcharge** ☒ **Evidence Of Surcharge** Depth: **2** (ft.) ☐ Active Surcharge Present

Adjustment, Corbel and Barrel root intrusion and infiltration. Corroded steps. Evidence of surcharge - Bench debris.

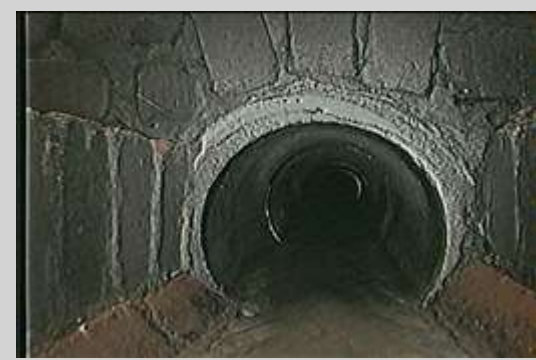
### 8 in. Circular Gravity Sewer Pipe Out @ 12 O'Clock

Barrel deterioration and infiltration.

Infiltration: **Evidence** Pipe Seal Cond: **Cracked**

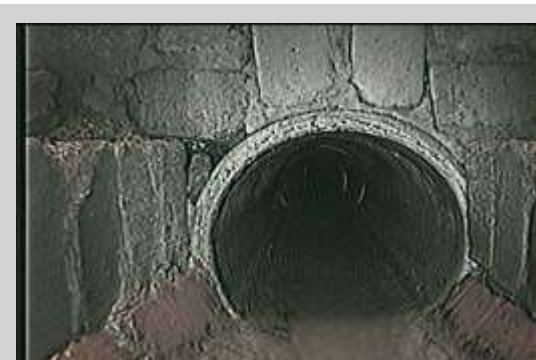
### 8 in. Circular Gravity Sewer Pipe In @ 6 O'Clock

Condition: ☐ Sound ☒ **Cracked** ☐ Root Intrusion ☒ **Deteriorated** ☐ Leaks ☐ Debris

Channel deterioration.

Infiltration: **Evidence** Pipe Seal Cond: **Cracked**
